Successful Non Explosive Radial Cutting Torch and Perforating Torch Cutter Operation to Cut 1.75" Coiled Tubing in Challenging Condition

One of key oil and gas operators conducted offshore coiled tubing operation to isolate the bottom plug prior to perforate and produce from new zone. The operator deployed 1 ¾" tapered coiled tubing had stuck at 3488m. After multiple attempts to free the coiled was unsuccessful.

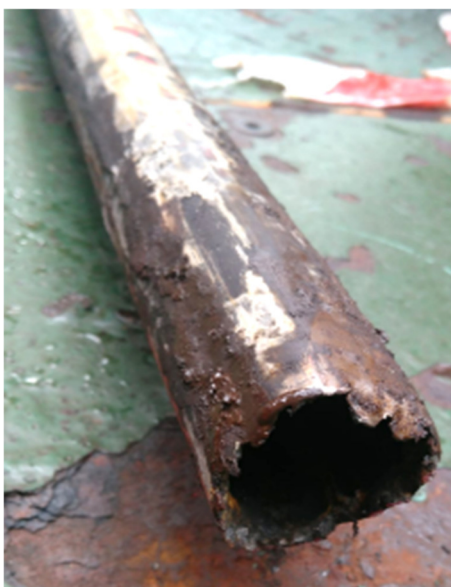
As a result, the 1.75" coiled tubing has been cut free by 7/8" RCT cutter safely and produce clean cut without any swell. It was found traces of cement at the one side of the coiled tubing when it recovered to surface. The success of this operation enable the operator to move forward to perforate the and produce from this reservoir.
